CASUALTY INVESTIGATION REPORT

HMS Ref: 07-31XX

Vessel:	1985 22' Angler Center Console	
HIN:	ANGF22XXXX85	
State Reg. #:	ME XXXXX X

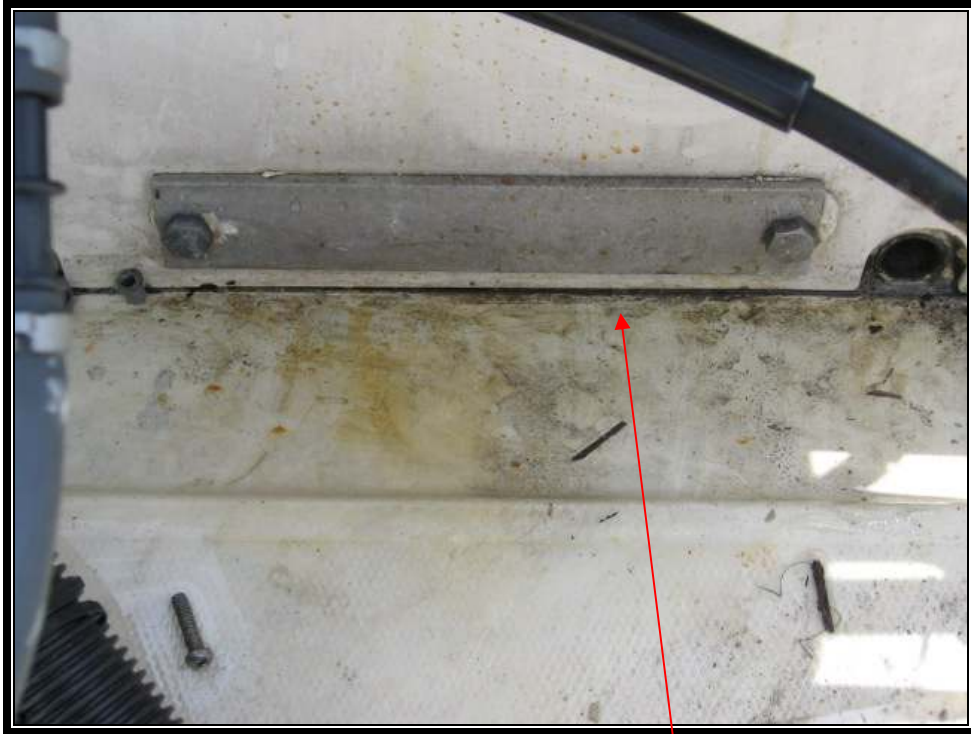
Primary cause – The original sealing calk at the aft end of the cockpit had deteriorated allowing water, entering at the transom scupper drains, to leak into the bilge. This area, according to the owner, commonly has had water in it when the vessel was afloat, due the top of the scupper drains being at or below the waterline. This appears to have been leaking for some time, but was not apparent due to the operation of the bilge pump. The bilge pump apparently failed, due to age and constant operation, and the vessel flooded and sank. The undersigned surveyor poured water into the aft area of the cockpit and observed water leaking into the bilge. (See photos below).

**Water has been weeping into the bilge through the separation
Water was poured in this area by this surveyor (See photo below)**

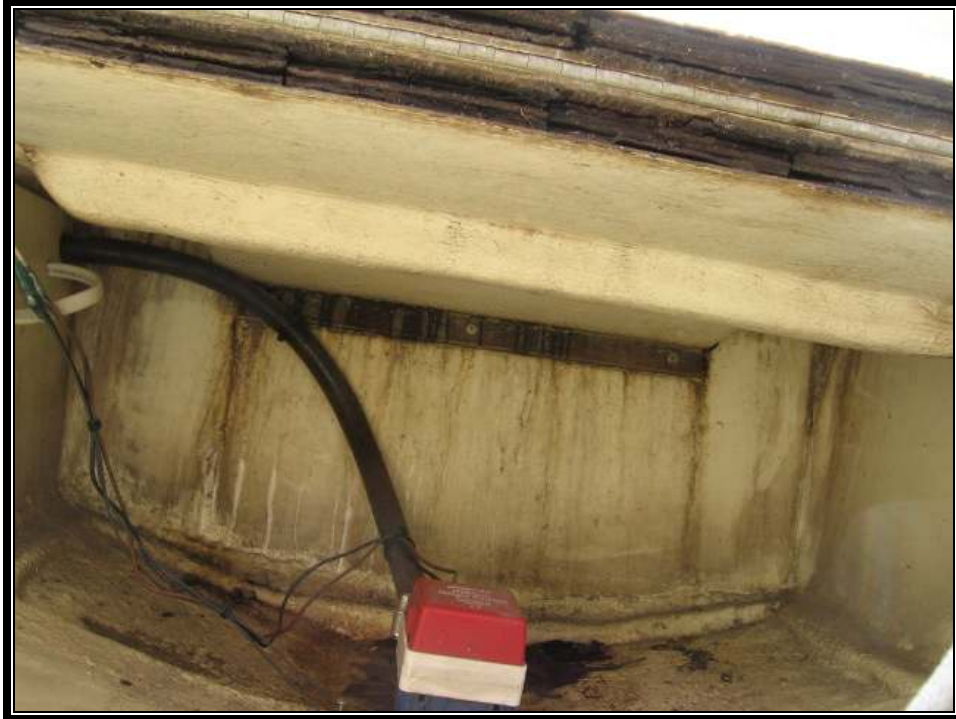
1. There are no through-hull fittings in the hull below the waterline and there was no damage to the underwater body.
2. The 12VDC battery was fully discharged. XXXXX XXXXXX stated that they used a test battery and found that the bilge pump and the float switch were inoperable. Further investigation indicated that the float switch was in good order but the bilge pump had failed internally.
3. The vessel was re-powered in 2005 (see enclosed invoice). The engine hour meter indicated 143.3 hours of use since re-powering.
4. Areas of the deck are delaminated (not a result of the sinking)
5. The SEA STAR hydraulic steering system is not damaged.

**Failed bilge pump with float switch;
Note the stains on the transom indicating leakage over time.**

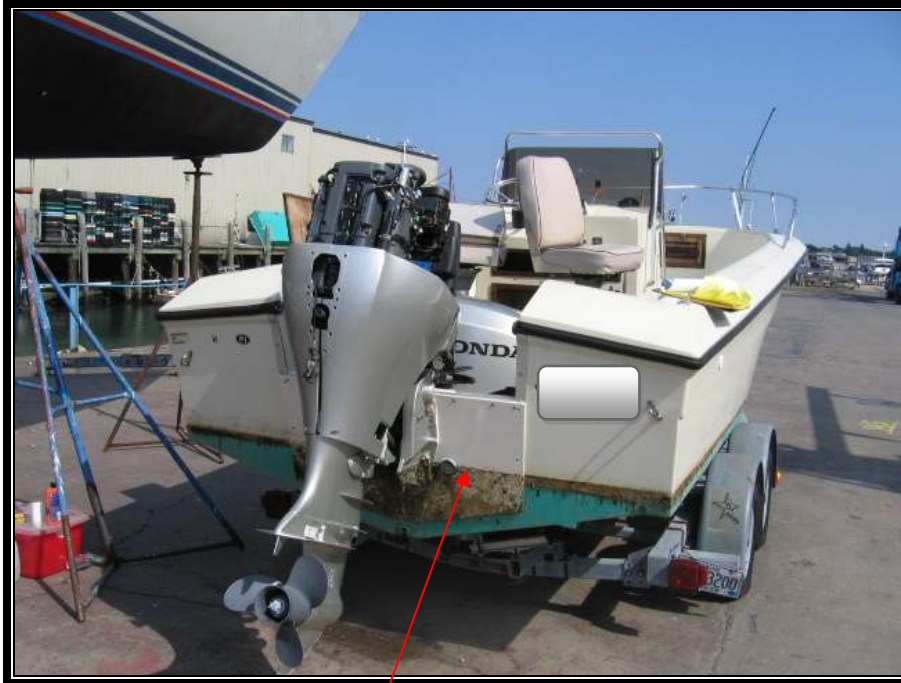
Secondary Cause – Prior to re-powering in 2005, the vessel was powered by a 140hp 2-stroke Johnson engine that weighed approximately 350#. The new engine (150hp 4-stroke Honda) weighs approximately 485#. This additional 135# of engine weight depressed the transom so that the drains were at or below the waterline.

Note location of waterline/scupper drain – This allows water to enter the vessel when it is afloat

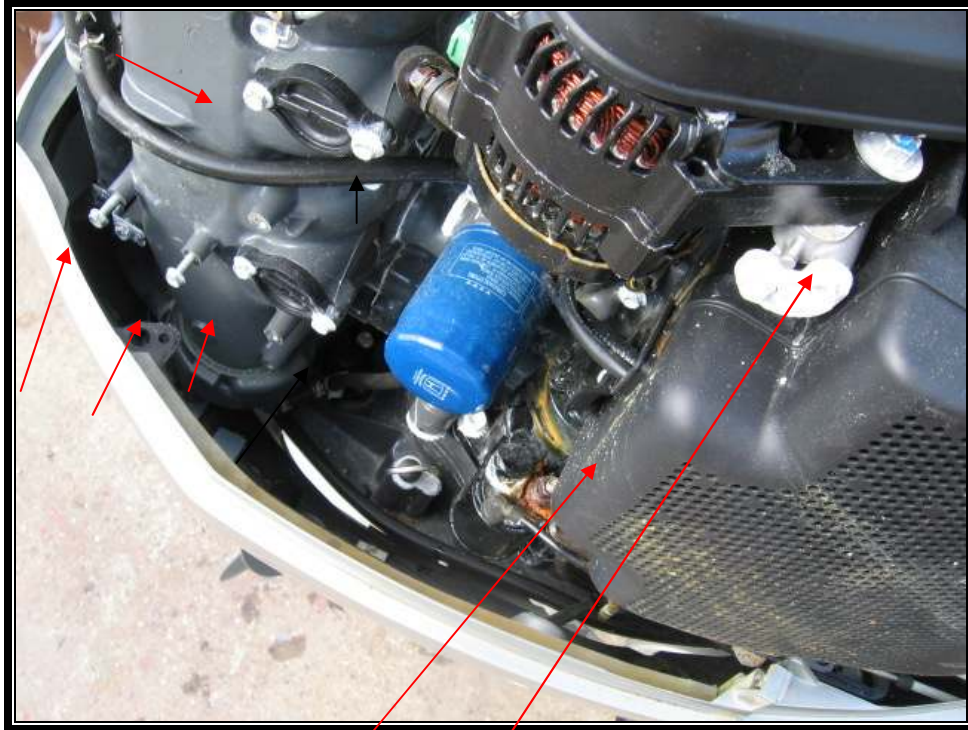
1. Areas of the engine are corroded (see photo) – salt water immersion.
2. Salt water in the engine oil – salt water immersion.
3. Battery is dead/not recoverable – salt water immersion.
4. Gauges and electrical wiring are inoperative/damaged – salt water immersion.
5. Electrical cables/engine controls are corroded/damaged – salt water immersion
6. Fuel contaminated with salt water.
7. Bilge pump is inoperative

Some of the rusted/corroded areas on the outboard

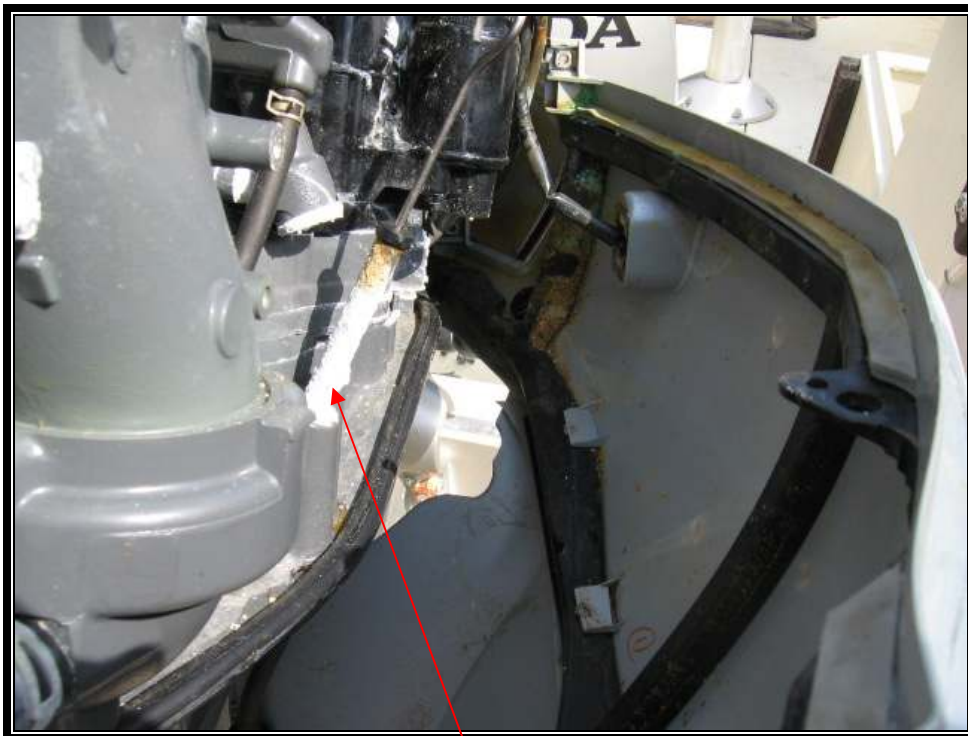
Corrosion

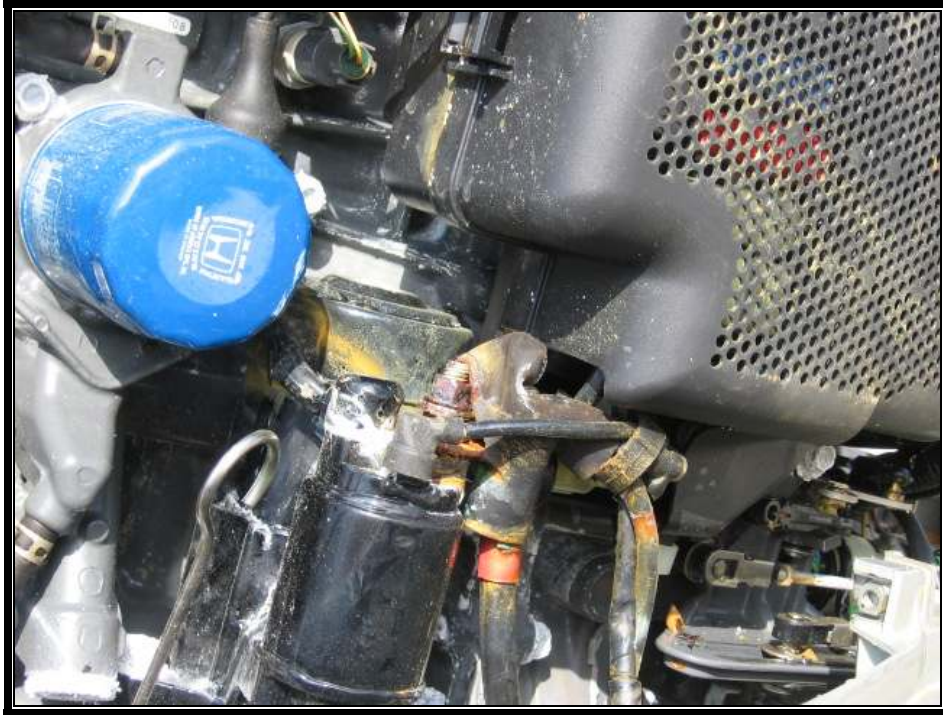
Rust and corrosion

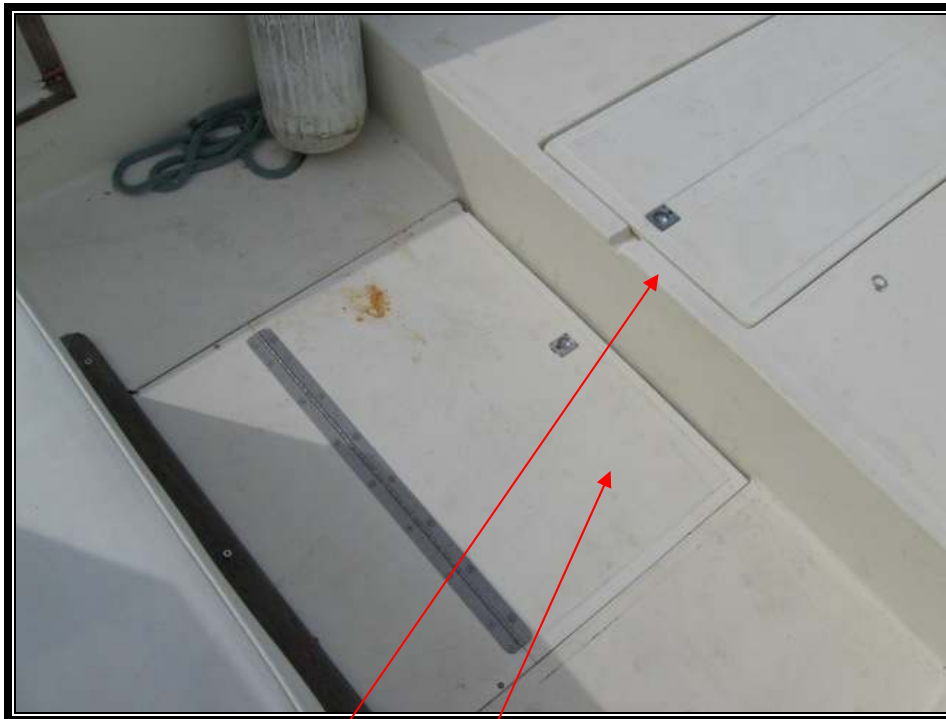
**Anchor locker drains overboard on the starboard side 5"+ above the water line:
Anchor locker and storage area also both drain aft to bilge pump along the centerline**

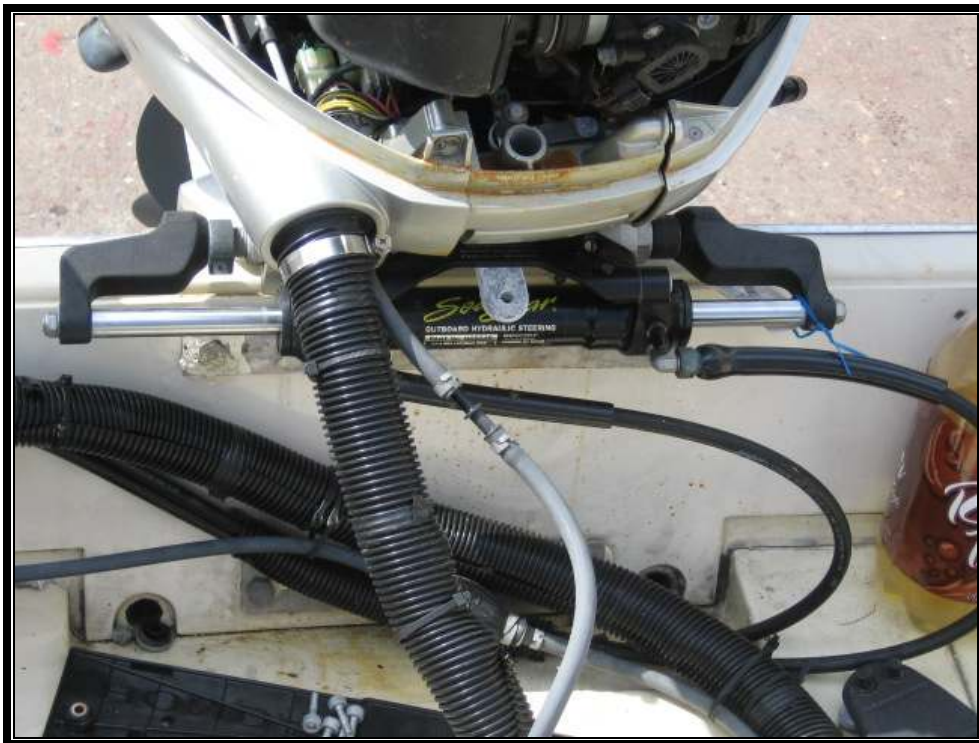
SEA STAR steering system does not appear to be damaged

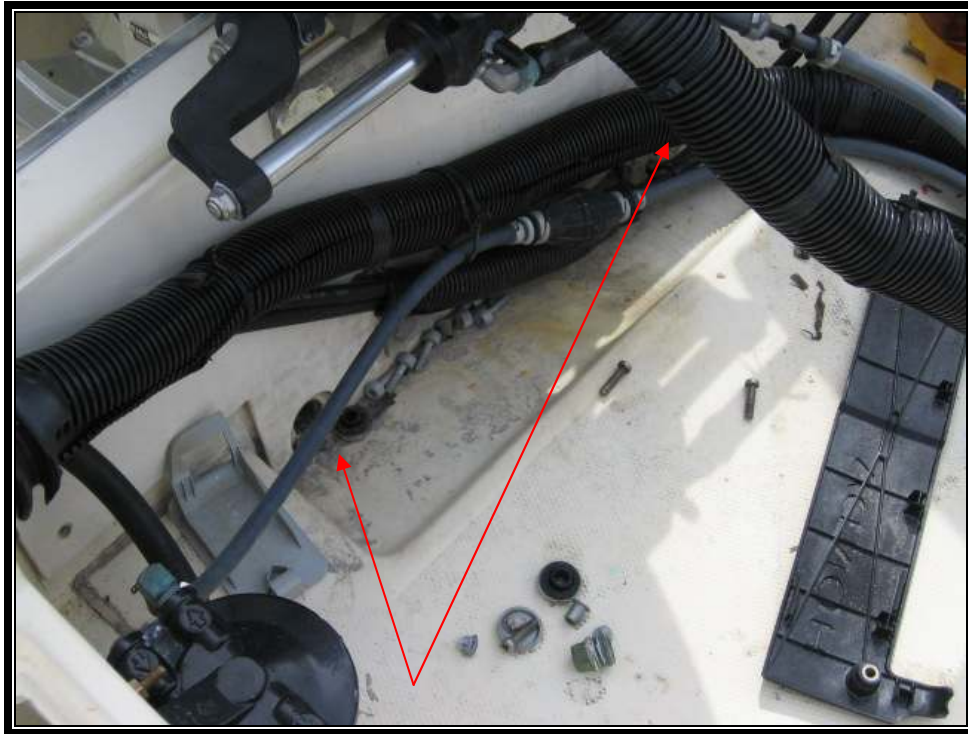
**Scupper drains are port and starboard in well;
The top of the well is 1/2" above top of scupper;**

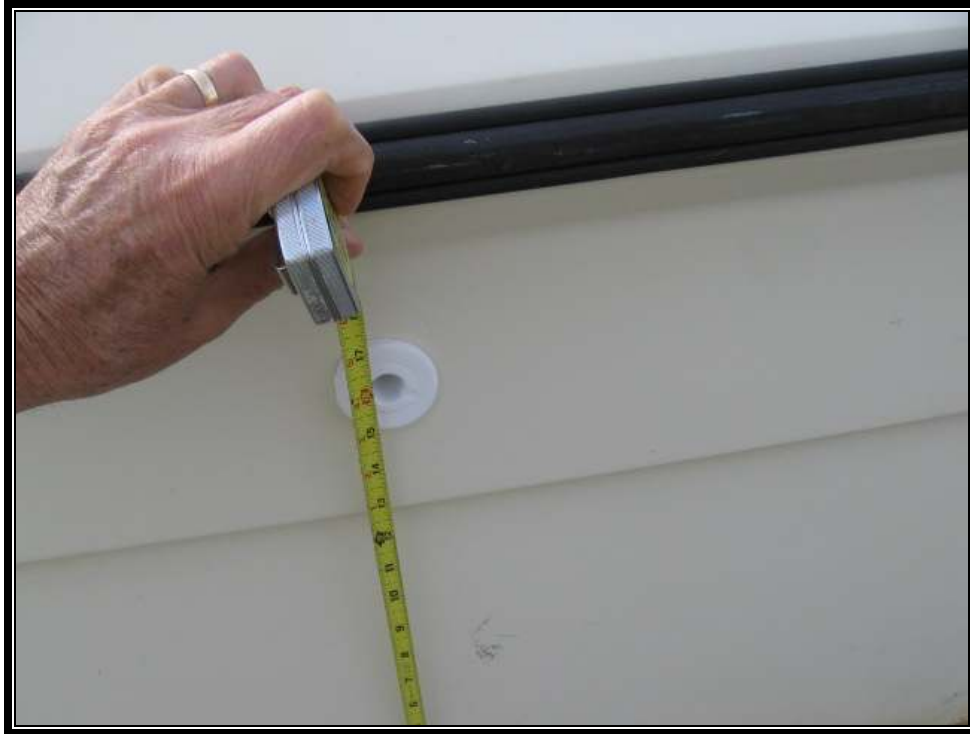
Bilge pump discharge fitting (16" +/- above waterline)

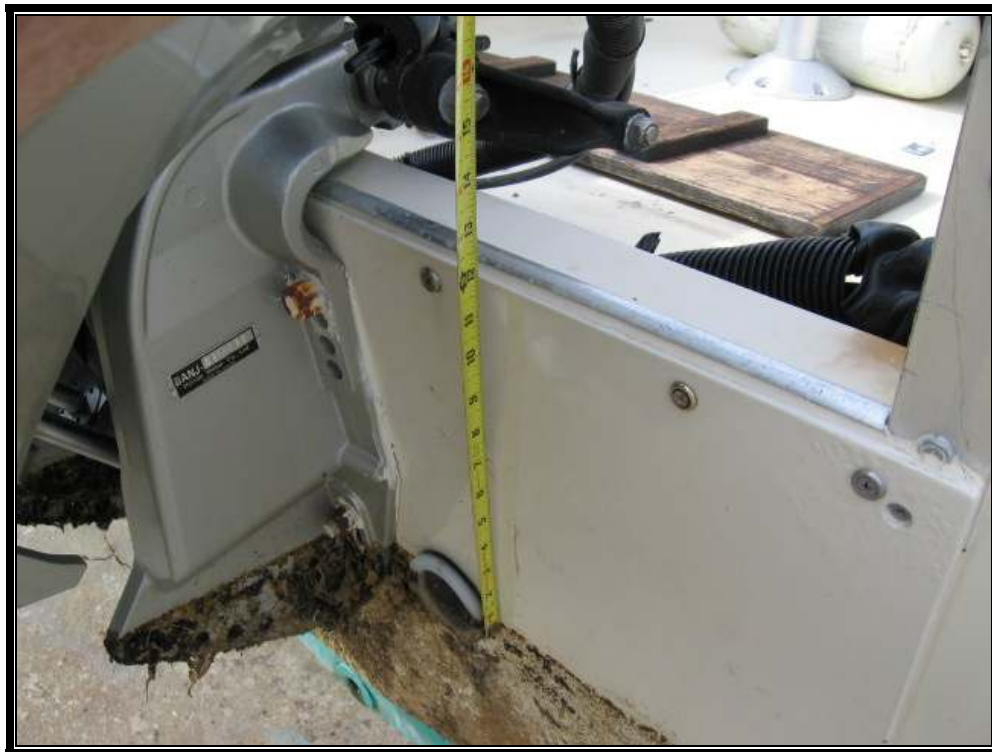
Freeboard aft = 12" +/- Note waterline near top of scupper
