HATHAWAY MARINE SURVEYORS

MARINE SURVEY REPORT

“M/V XXXXXXXXX”

SURVEY DATE: XXXXXXXXX
YEAR BUILT & MODEL: Carver 366
VESSEL TYPE: FRP Fly bridge Aft Cabin
VESSEL MANUFACTURER: Carver
MANUFACTURER LOCATION: Pulaski, WI
DESIGNER: Carver
HULL IDENTIFICATION NUMBER: XXXXXXXXXXX
VESSEL HAILING PORT: N/A
OFFICIAL NUMBER: XXXXXXXXXXXXX
GROSS TONNAGE: 20
NET TONNAGE: 16

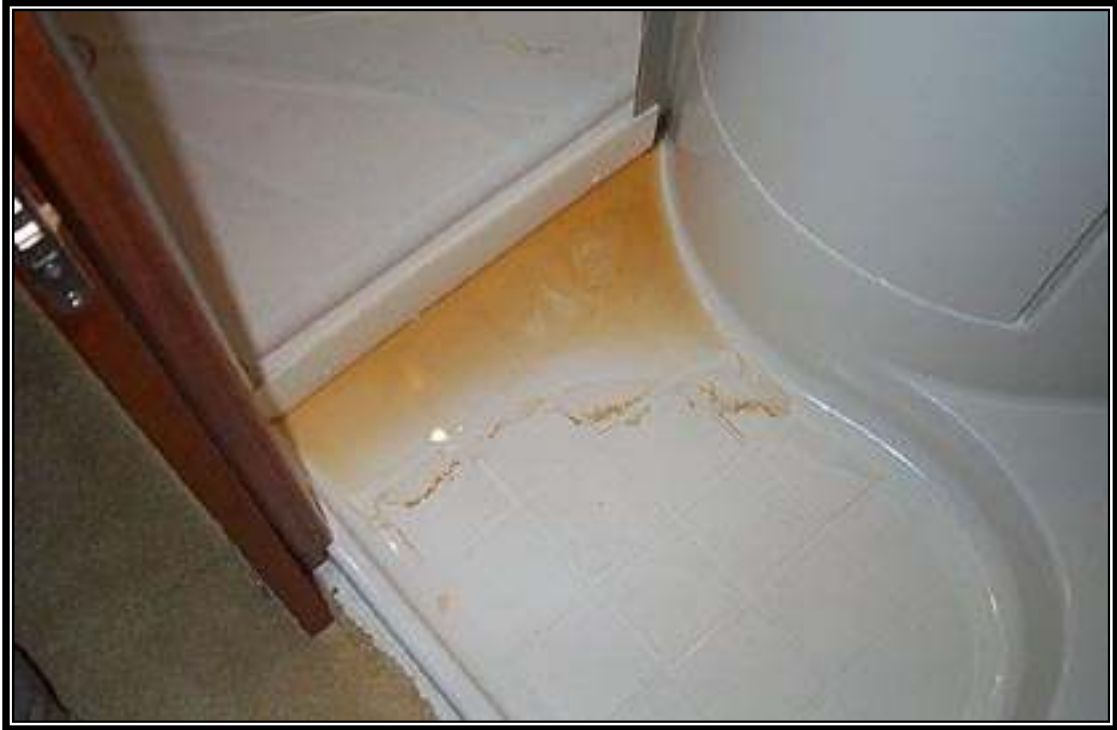
Ice in Aft Stateroom Head Area

1. Remove ice from the aft head compartment. 📷
2. Ensure that the vessel and all of her systems are properly winterized.
3. Re-bed the anchor roller mount and the windlass to stop further entry of moisture. 📷
4. Monitor the swim platform for moisture and non-lamination. Make permanent repairs when and if required. This is not a structural liability at this time.
5. The vessel’s 12VDC batteries were aboard at the time of survey and were being continuously charged. Verify their condition for continued service.
6. Make the trim tabs operable.
7. Replace the deteriorated seal serving the 110VAC power cable locker cover. 📷

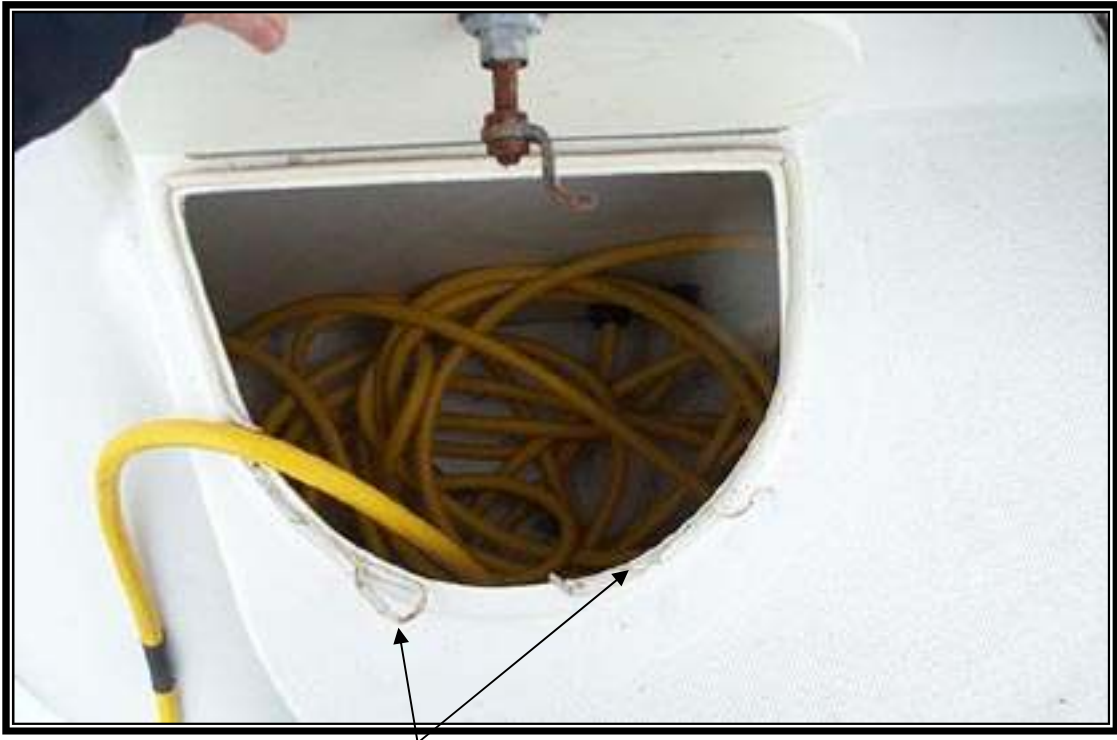
Deteriorated Cover Seal at Power Cord Storage Locker

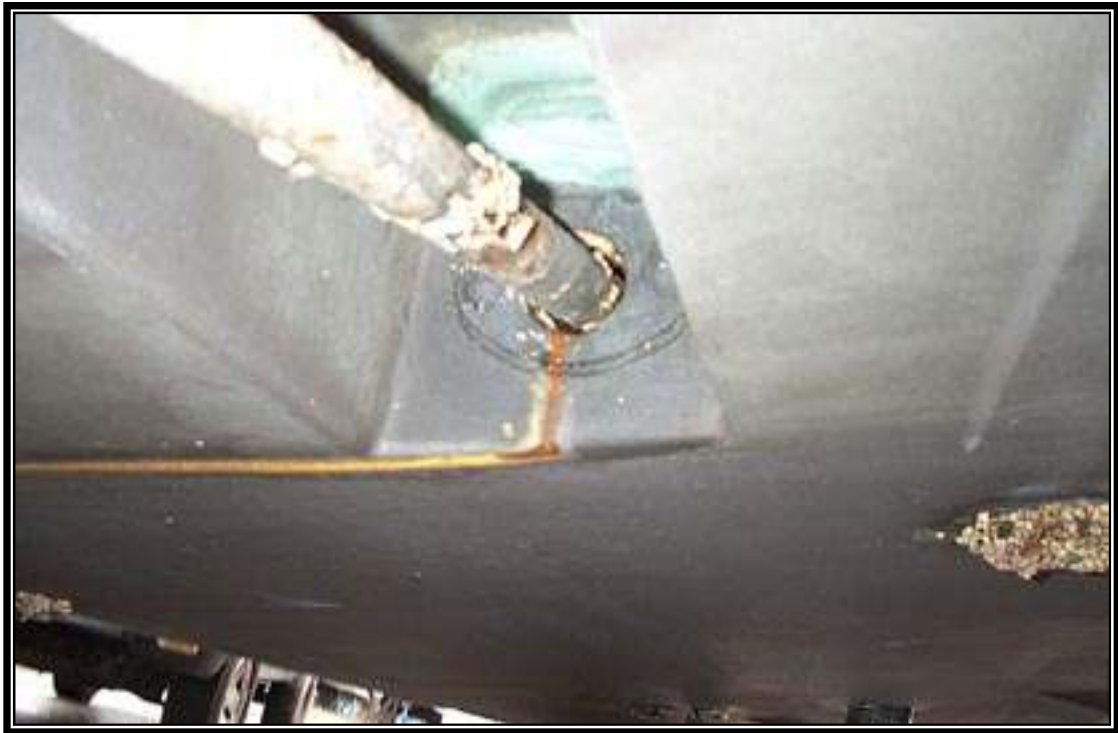
The vessel's port side cutless and intermediate bearing, both propeller shafts, both propellers and struts were examined and found to be in acceptable condition. The starboard cutless bearing and intermediate bearing both exhibit excessive clearance ▼ 📷. There appears to be some rust staining at the point where the starboard propeller shaft enters the hull. ▼ 📷

Starboard Propeller Shaft – Note Discolored Drippage

1. The starboard propeller shaft cutless and strut bearings exhibit excessive clearance that is not seen on the port shaft. Determine the cause, replace the bearings, and make repairs/adjustments as required.
2. Free up/lubricate/overhaul the "frozen" seacock associated with the forward AC unit's raw water intake.
3. Secure the loosened (portside) outboard grab rail at the transom boarding gate. 📷 This is a possible safety hazard.

6. Remove barnacles and sea-growth from all raw water intake strainers, propeller shafts, rudders and struts.
7. Determine the source of the rusty/discoloration appearing at the starboard propeller shaft where it exits the hull. 📷 Make repairs if warranted.

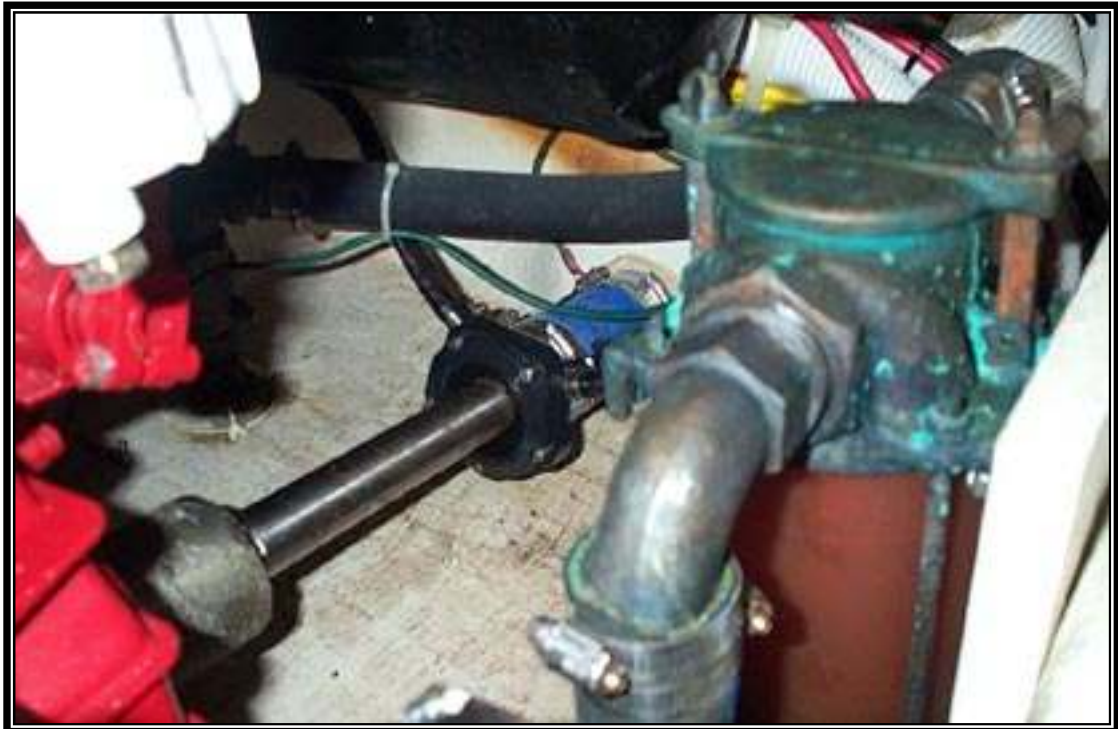
The "dripless" stuffing boxes and flexible hose sections appear to be in acceptable condition. 📷

Starboard Propeller Shaft Log

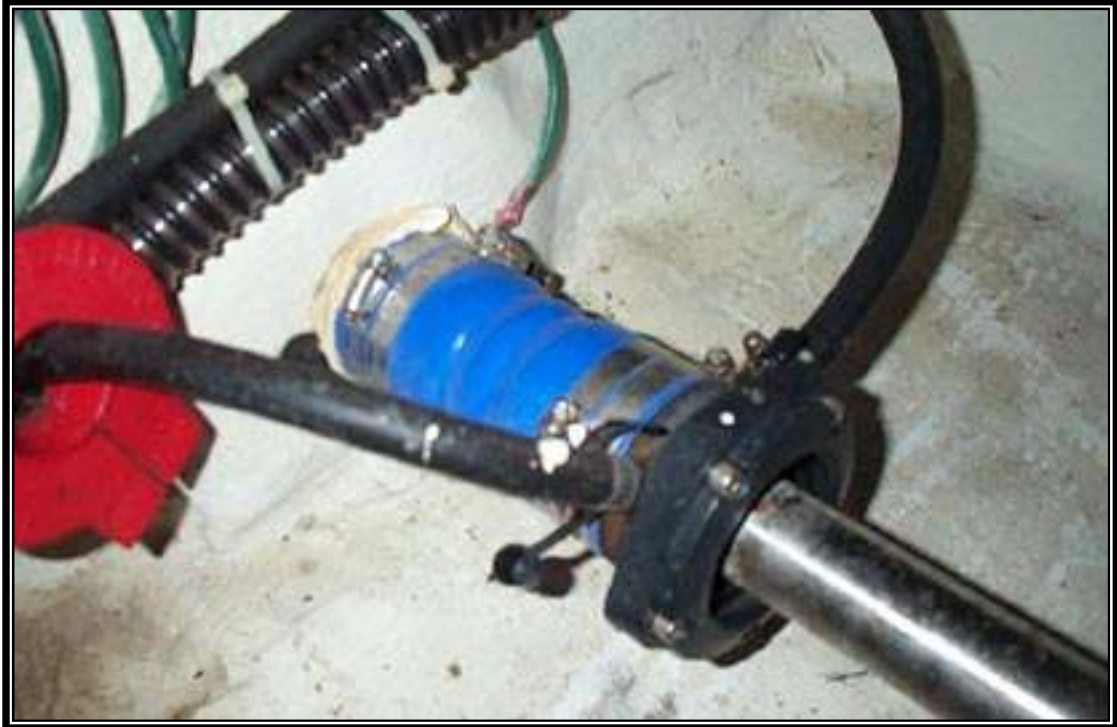
Port Propeller Shaft Log

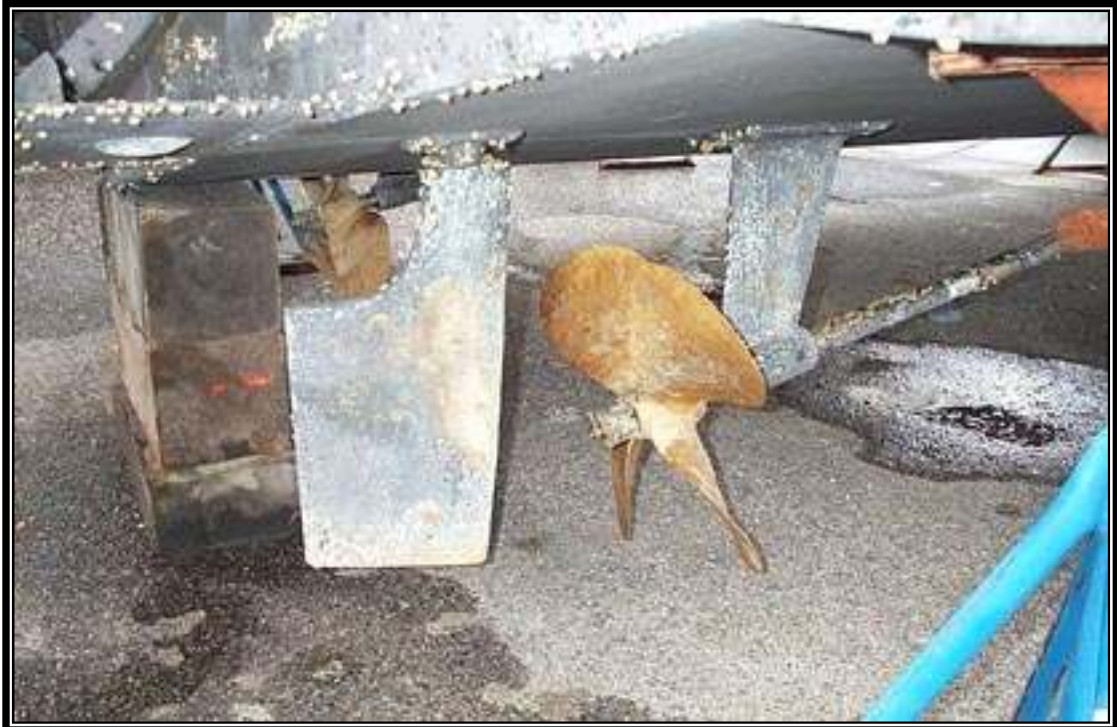
Note Accumulation of Barnacles

8. Remove the accumulation of marine growth from the underwaterbody, rudders, shafts, etc. 📷
9. Monitor the plastic through-hull fitting on the port side amidships that exhibits surface deterioration due to ultra violet rays 📷. Replace when and if required.

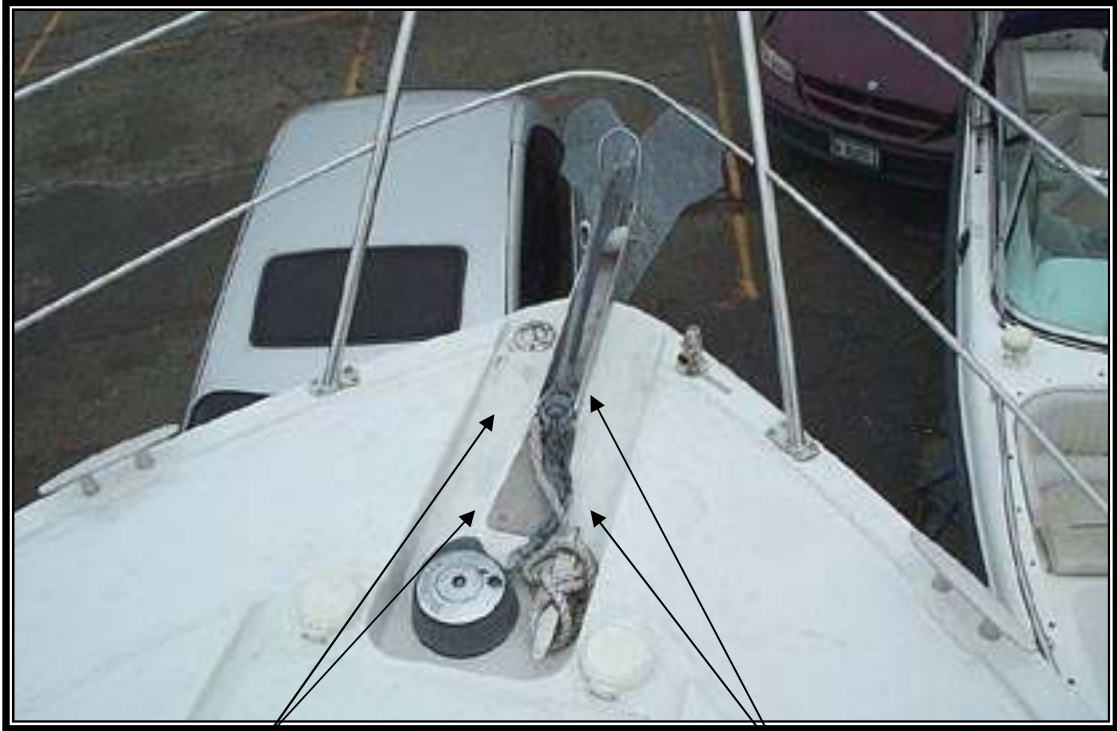
Moisture content of the laminate was found to be within acceptable limits except as noted below ▼:

1. Areas of the swim platform, with scattered small areas of non-lamination.
2. Areas of the anchor mount and windlass, with no clear indications of non-lamination.

Small Areas of Elevated Moisture Meter Readings

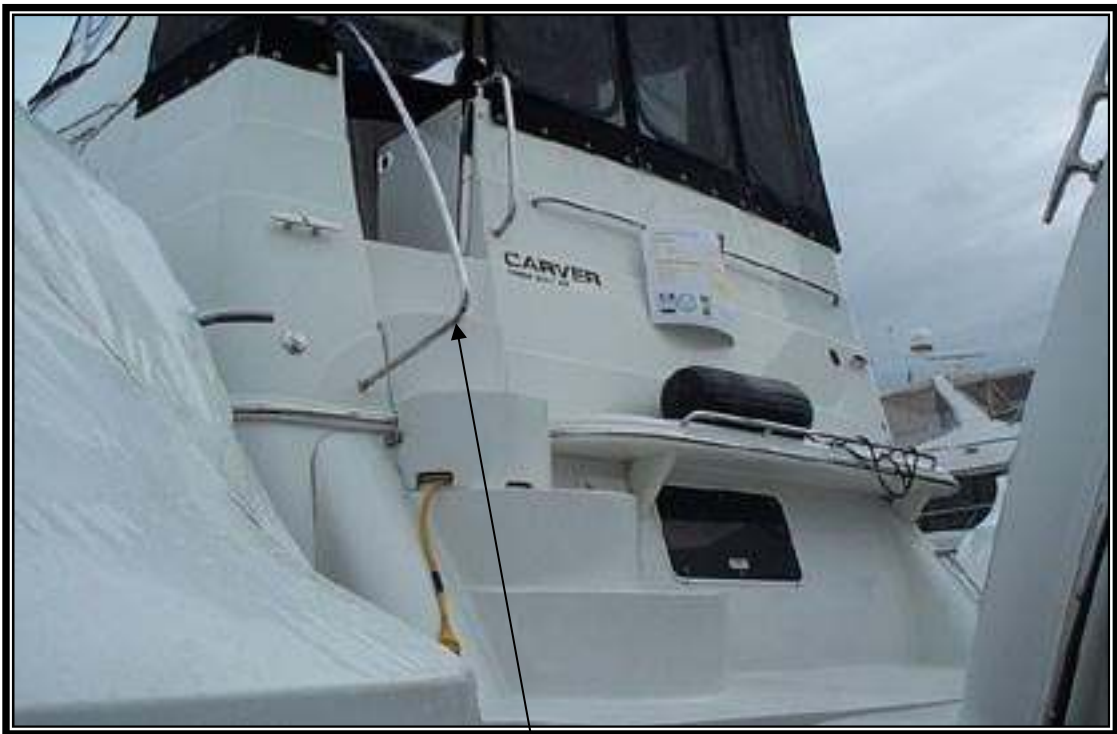
Guardrails/lifelines and bases were visually inspected and side-loaded and found to be in acceptable condition with the exception of the portside handrail leading from the swim platform to the transom gate ▼

Loose Hand Rail

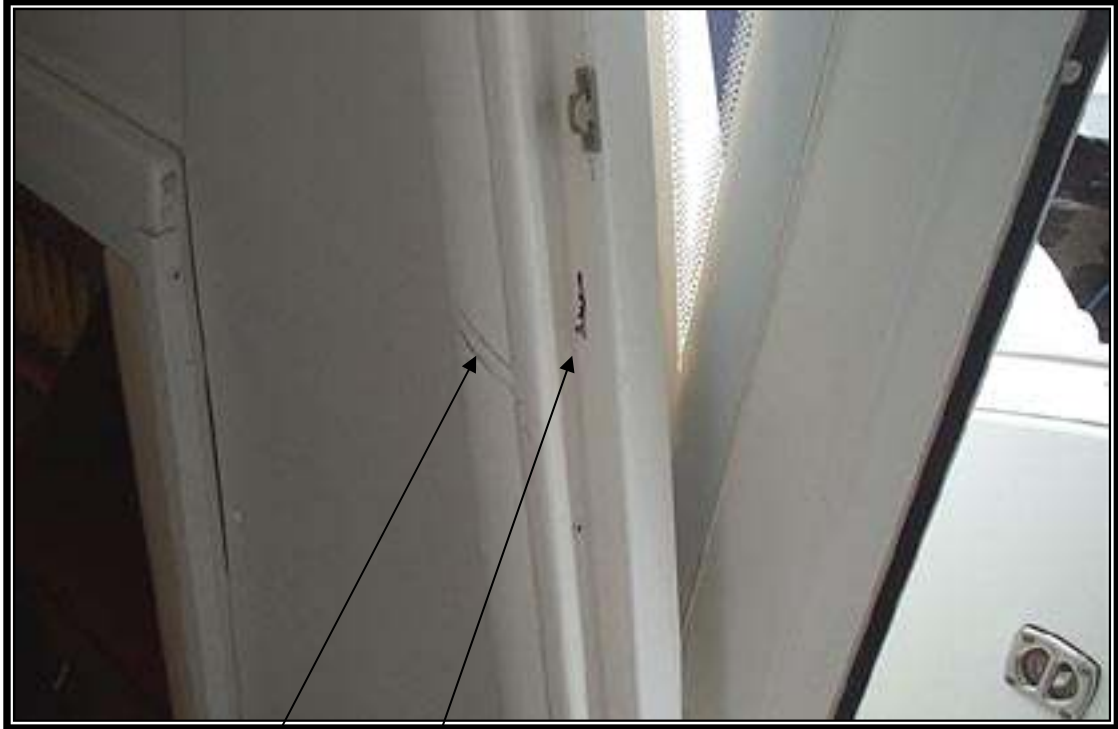
Scrape & Chipped Gelcoat at Cabin Entrance

17. For the Record: There is a "scratch" on the port side wing door.
18. For the record: There are some minor gel coat chips in way of the main cabin entrance 📷

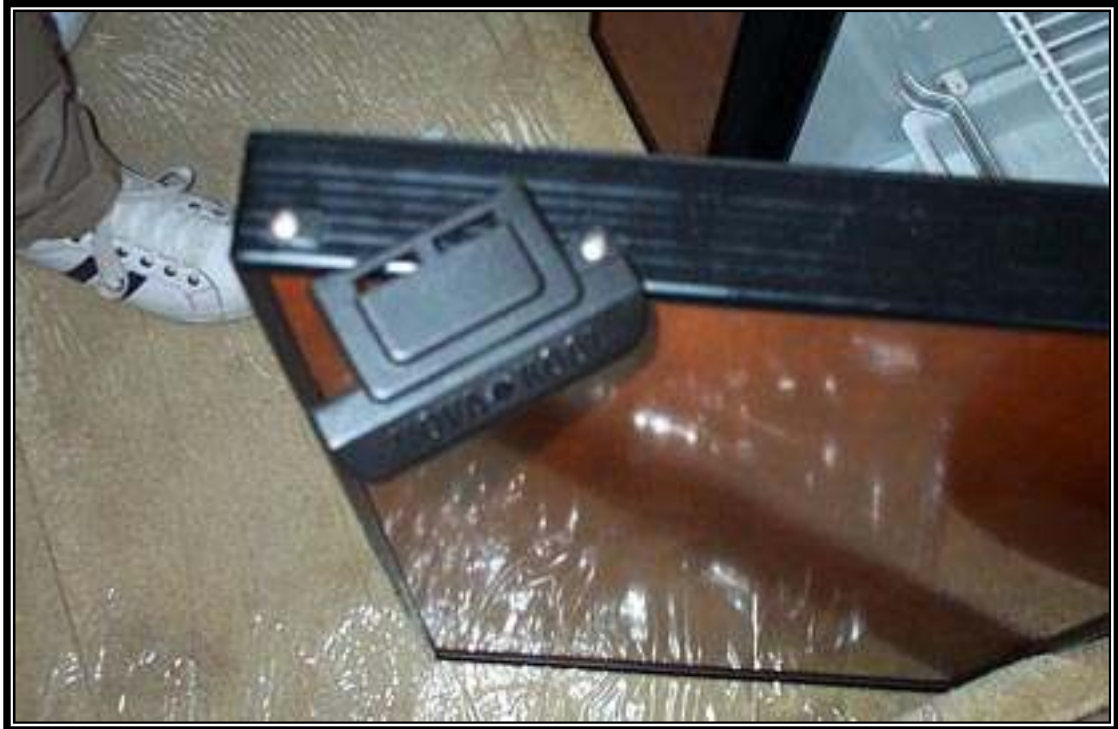
Broken Refrigerator Handle

3. Provide fire extinguishers for the cabin spaces that have "Class A" capability.
4. Carry out sea trials as outlined in text of the survey.
5. Replace broken latch on refrigerator door. 📷

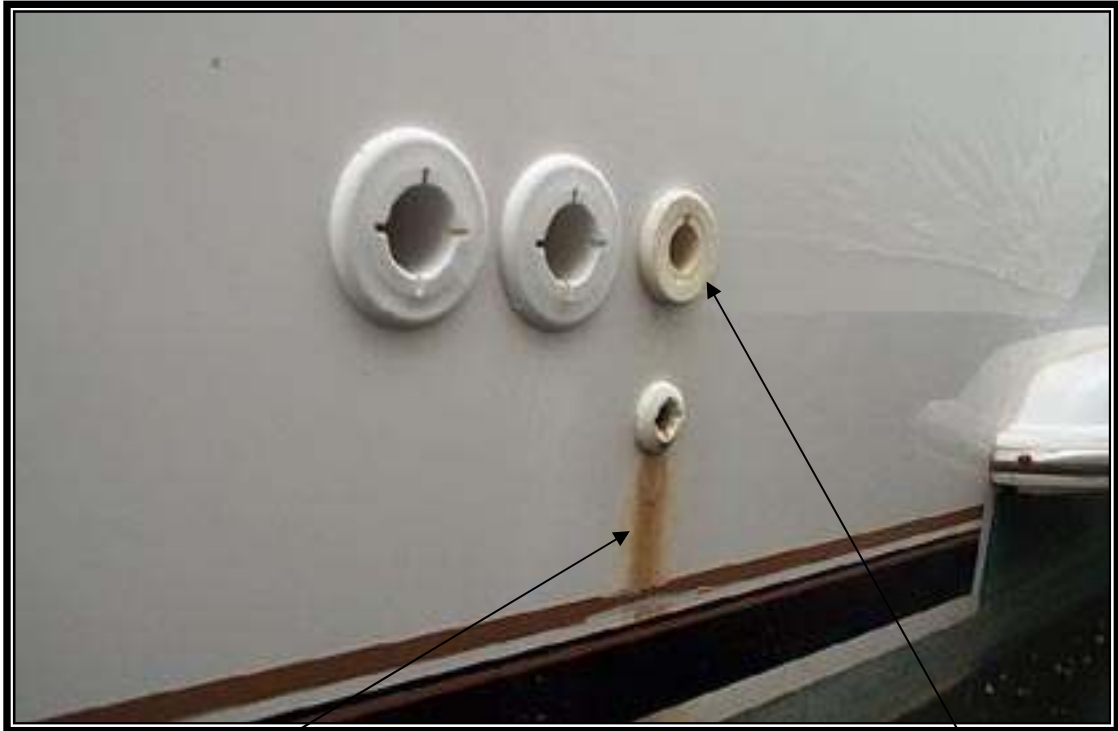
Discoloration at Portside Drain – Through-Hull Showing UV Deterioration

10. Determine the source of the discoloration at the port and starboard drains. Make repairs if warranted.
11. Suggestion: Sanitize the domestic fresh water system.

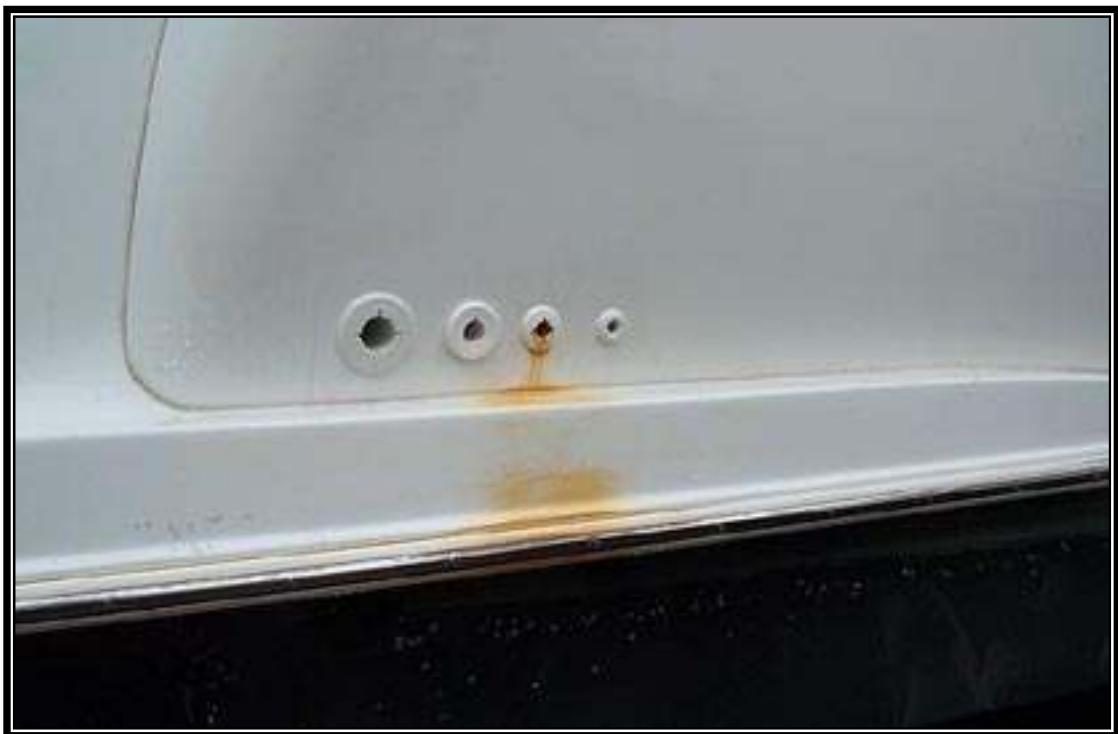
Discoloration at Starboard Drain

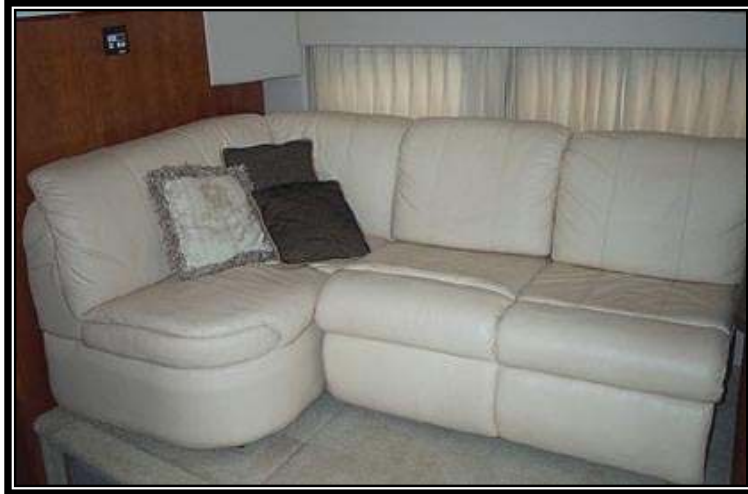
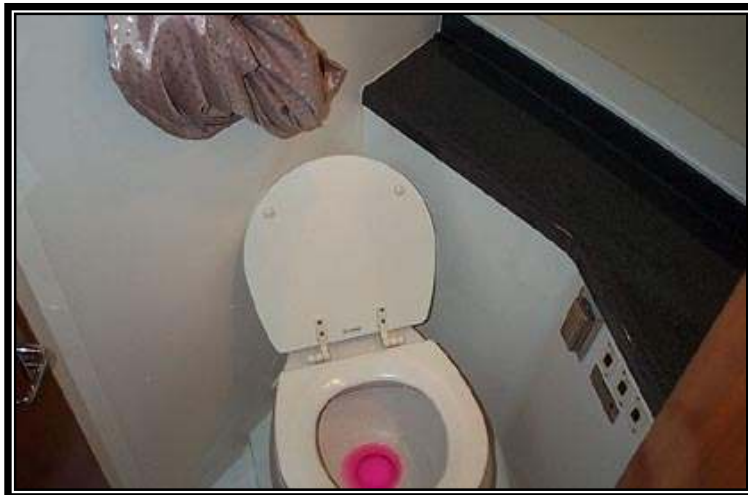
Fwd Head – Note Antifreeze
