Findings

Hathaway Marine Services, Inc.
Marine Surveyors

Winter, 2008-9

Shaft Logs & Stuffing Boxes – Out of sight..Out of mind

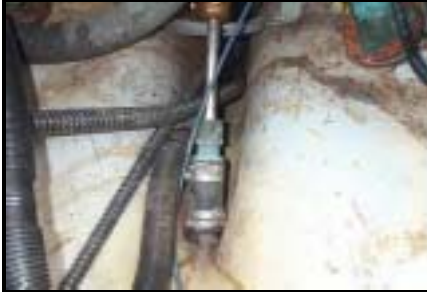
The photo above shows a typical shaft log and stuffing box that is in acceptable condition. The shaft, from the engine (top of photo) goes through the bronze stuffing box and then through a length of flexible rubber hose that is clamped to the stuffing box and then (at bottom) to a molded fiberglass tube that leads out of the hull.

The hose clamps are at the extreme ends of the hose section. This allows the hose to flex and absorb engine vibrations. The stuffing box is "packed" with several rings of waxed flax material that provides a seal around the shaft. The stuffing box, when properly adjusted, should not leak when the shaft is idle and then leak 5-10 drops/minute when turning. The leakage is needed to cool the packing in order to reduce shaft wear and packing failure due to frictional heat.

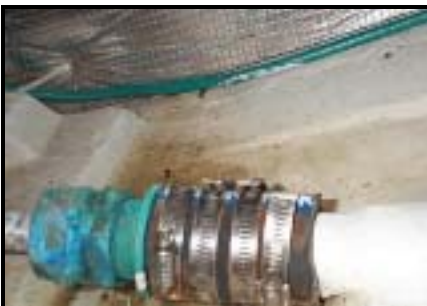
In the photo above, although on a fairly new boat, the flexible hose section is too short to allow the hose

to flex. This could eventually lead to early hose failure if not corrected.

Rubber hoses deteriorate over time. The constant act of flexing will eventually break down the material. Although there are no set rules, probably 5-8 years would be a prudent replacement cycle.

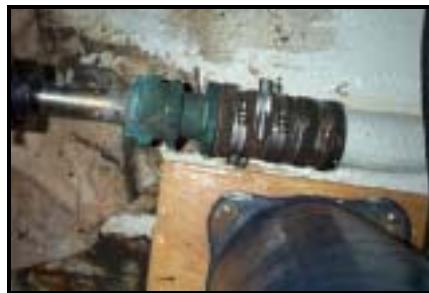
Adding more clamps gains you nothing. The center clamp (below) guarantees the inflexibility of the hose section and probably indicates that there is not sufficient space between the fiberglass tube and the aft nose of the stuffing box. By the time that we saw it, the hose had begun to crack.

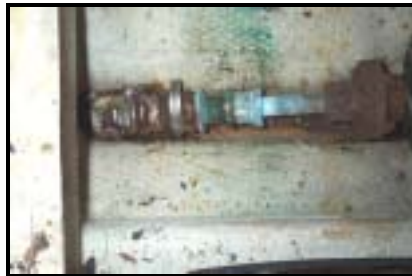
High quality marine-grade clamps are an absolute necessity. Those below were probably sub-grade when installed and clearly have not improved with age. Look for items like these.

Flax packing, whether the traditional wax or the newer Teflon filled, is not "forever". When the hose section is being replaced it would be a good time to change-out the packing. And don't scrimp on hose clamps. Use only marine-grade 316 stainless steel. The stainless steel clamps at the hardware store are generally not suitable for critical marine applications.

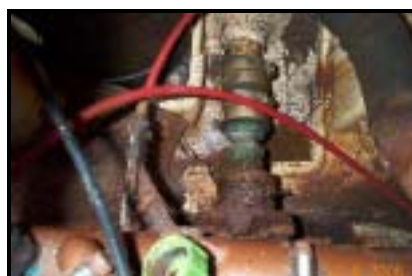
Stuffing box leakage can become excessive if not properly adjusted. The leakage was so great, in the photo below, that salt spray seriously damaged the aft areas of the reverse gear and engine. The owner had never noticed anything except that the bilge pump ran often.

Adjusting a stuffing box for the correct drip rate is easy, but you'll need two large wrenches. Wrenches specifically made for this purpose are sold at chandleries and should be part of your onboard tool kit.

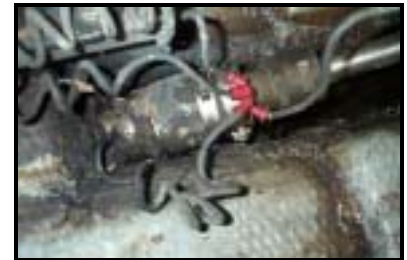
We were impressed with the attempt at electrical grounding shown below. The wires, with the red crimp covers, were clamped to the flex hose preventing the wires from carrying any current to anyplace. It looked hi-tech but did nothing. Upon removal of the clamps, the flex hose was found to be deteriorated and required immediate replacement.
